This spreadsheet performs screening level calculations to estimate the effect of peeling leaded paint on the average concentration of lead in yard soil
3770 Gilpin Street

LBP Assessment Results

Property # 3411 / 3770 Gilpin Street

SITE NAME: VASQUEZ BLVD AND I70

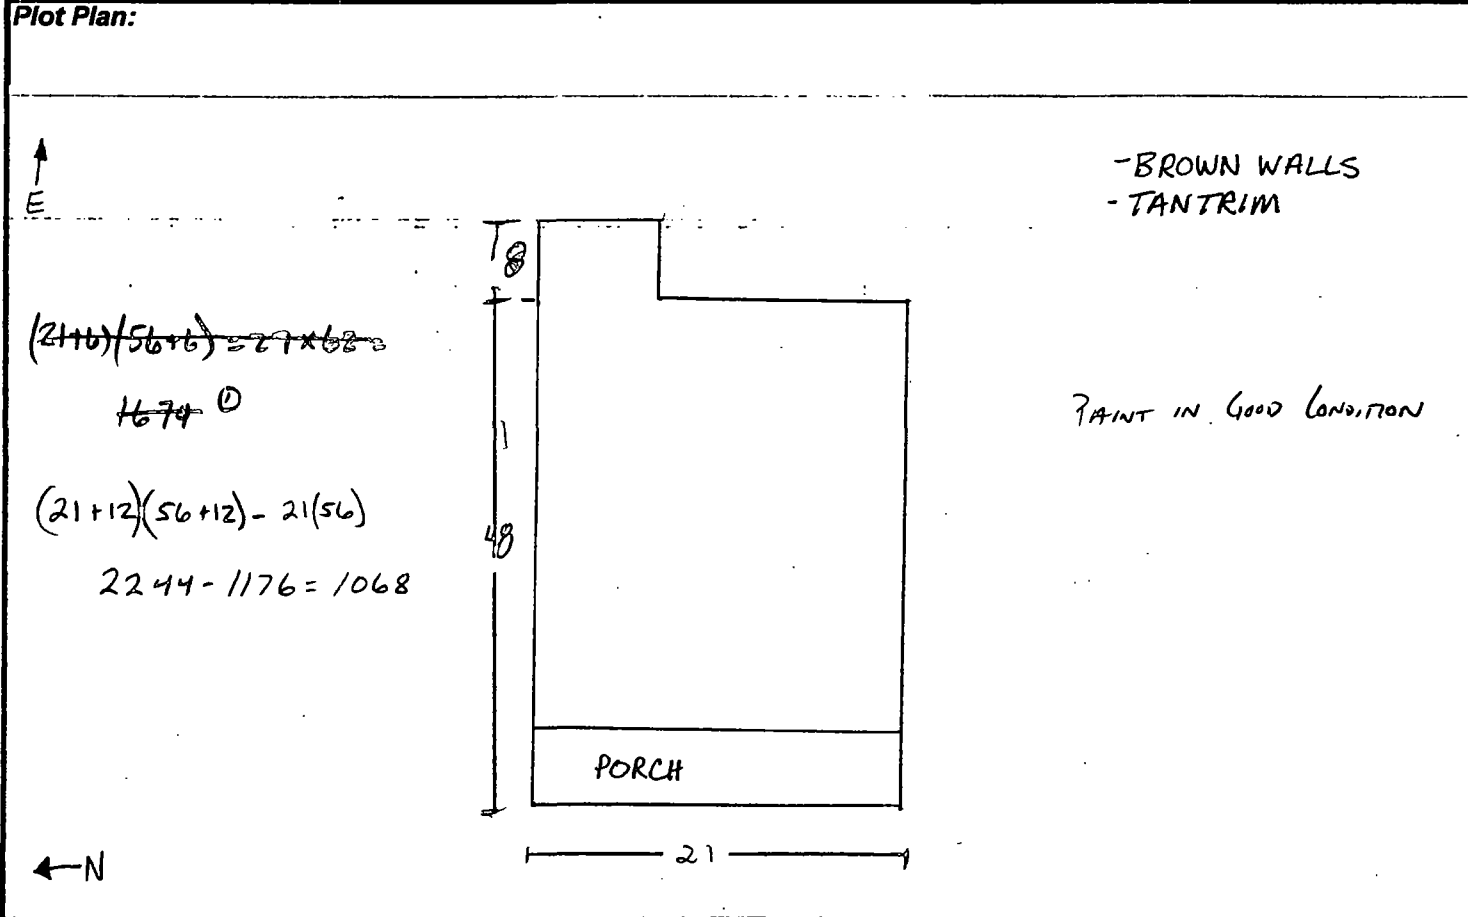
GILPIN STREET

Exterior Walls				Doors/Trim			
	Material	Area	Peel/Chip	XRF (Lead)	Material	Area	Peel/Chip	XRF (Lead)
North								
South	CEMENT	—	—	—				
East	WOOD SIDING	—	—	—				
West	BRICK	—	—	NULL				
	Total				Total

Window Trim/Fascia/Soffit				Patio/Decks/Porches			
	Material	Area	Peel/Chip	XRF (Lead)	Material	Area	Peel/Chip	XRF (Lead)
North								
South	WOOD SILL	—	—	24.4	WOOD TRIM	—	—	8.6
East								
West	BRICK SILL	—	—	19.3	BRICK	—	—	—
	Total				Total

Metal Trim/Gutters/Downspouts				Misc Structures/Garage/Fences			
	Material	Area	Peel/Chip	XRF (Lead)	Material	Area	Peel/Chip	XRF (Lead)
North								
South								
East					CLOTHESLINE METAL	—	—	—
West								
	Total				Total

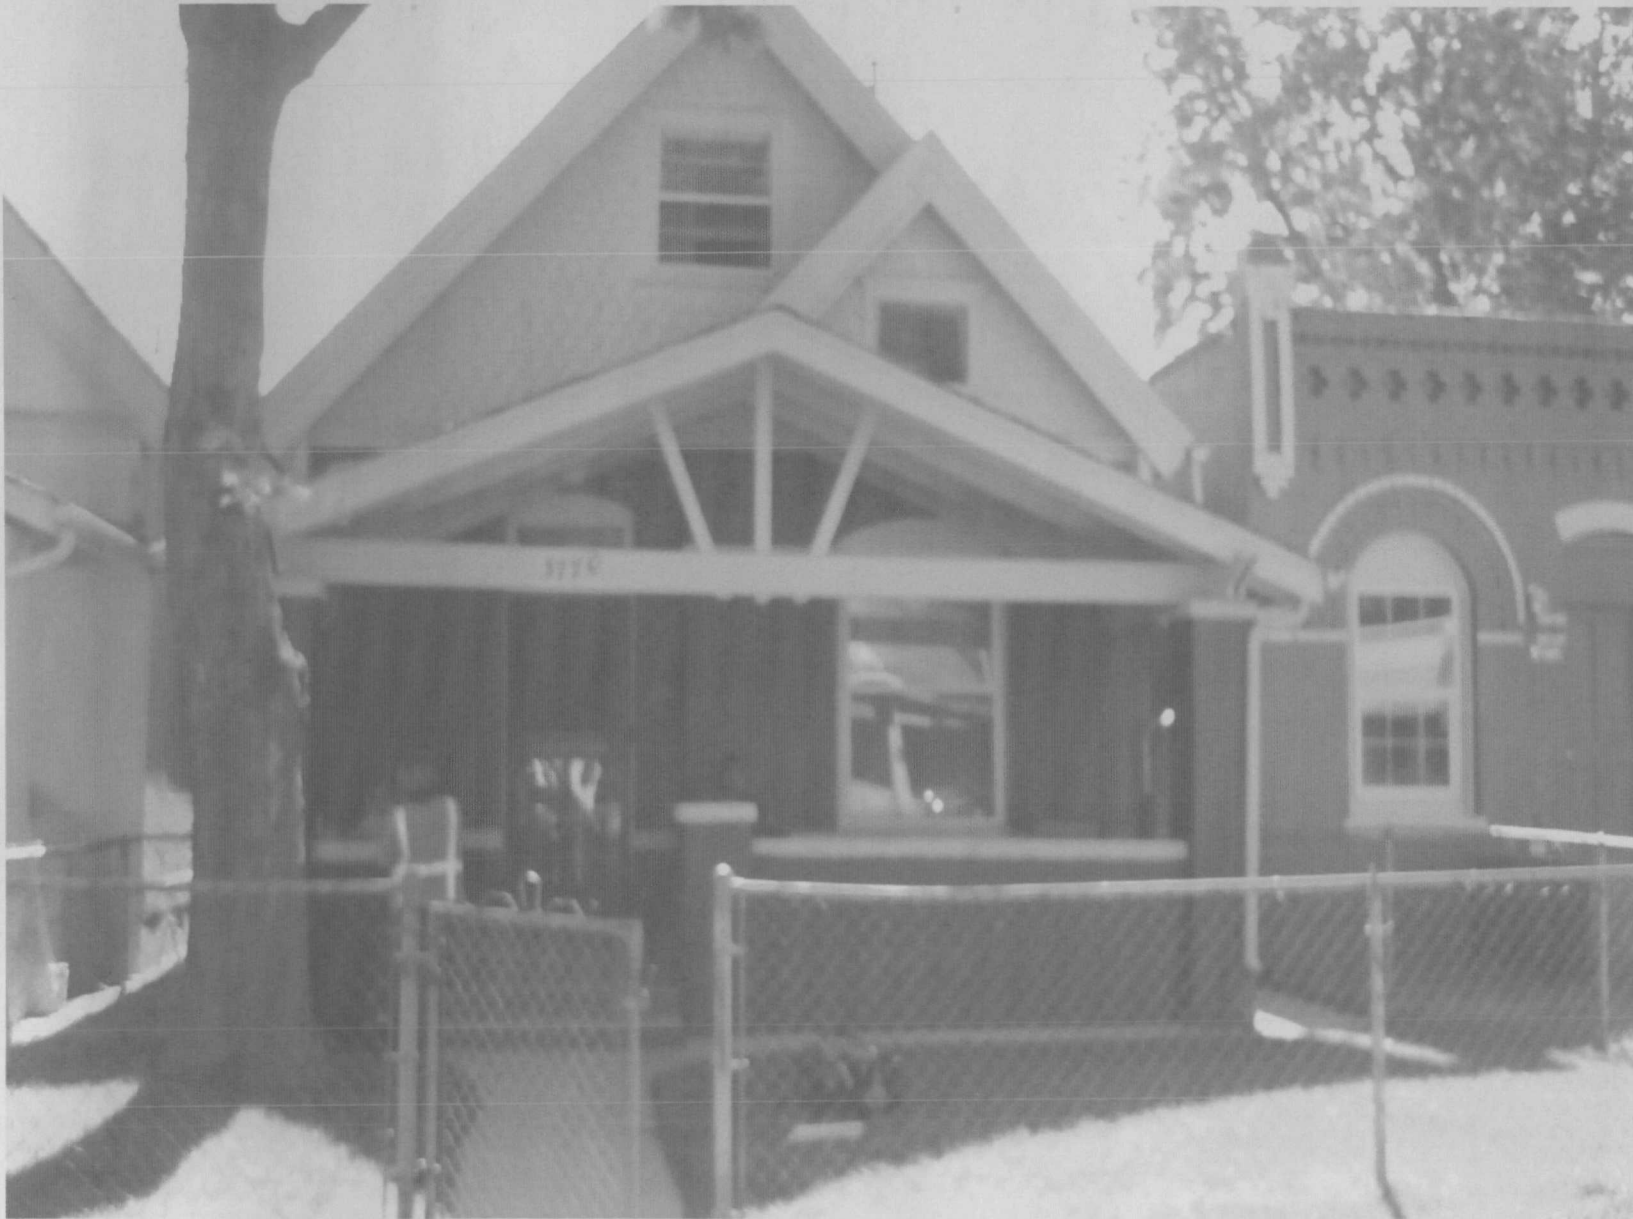
3411

Tan wood trim contains lead paint in good condition (recently painted)
